# REPORT

**Mini Countryman**

## PAS: general interpretation, body

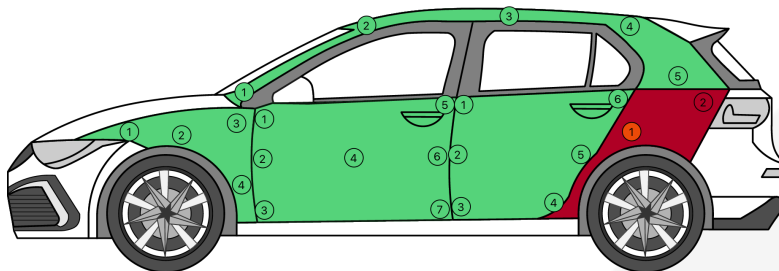
| LEFT SIDE | | | | | | | | | | | |

| LEFT SIDE | | | | | | | | | | | |
|---|---|---|---|---|---|---|---|---|---|---|---|
| left front fender/ bumper | Fe | 75 | 96 | 84 | 96 | 88 | 76 | 75 | - | - | - |
| left front door | Fe+Zn | 71 | 111 | 86 | 77 | 111 | 98 | 83 | 71 | 89 | 75 |
| left rear door | Fe | 115 | 165 | 146 | 149 | 162 | 115 | 136 | 149 | 165 | - |
| left pillar | Fe | 113 | 160 | 134 | 160 | 142 | 125 | 113 | 130 | - | - |
| left rear fender/ bumper | Fe+Zn | 313 | 570 | 442 | 313 | 570 | - | - | - | - | - |

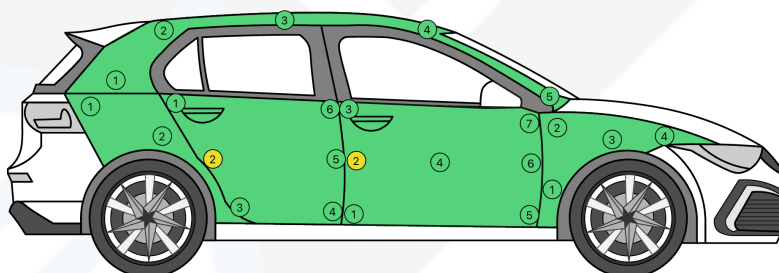
| RIGHT SIDE | | | | | | | | | | | |

| RIGHT SIDE | | | | | | | | | | | |
|---|---|---|---|---|---|---|---|---|---|---|---|
| right front fender/ bumper | Fe | 85 | 121 | 100 | 100 | 85 | 92 | 121 | - | - | - |
| right front door | Fe+Zn | 52 | 111 | 83 | 76 | 52 | 79 | 111 | 83 | 91 | 91 |
| right rear door | Fe+Zn | 61 | 160 | 92 | 88 | 61 | 79 | 82 | 84 | 160 | - |
| right pillar | Fe | 126 | 145 | 133 | 136 | 126 | 131 | 145 | 128 | - | - |
| right rear fender/ bumper | Fe | 75 | 92 | 84 | 75 | 92 | - | - | - | - | - |

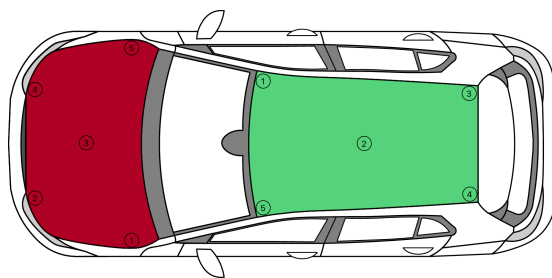
| TOP | | | | | | | | | | | |

| TOP | | | | | | | | | | | |
|---|---|---|---|---|---|---|---|---|---|---|---|
| hood/bonnet | Fe+Zn | 530 | 677 | 621 | 530 | 645 | 661 | 592 | 677 | - | - |
| roof | Fe | 127 | 148 | 135 | 129 | 148 | 132 | 139 | 127 | - | - |

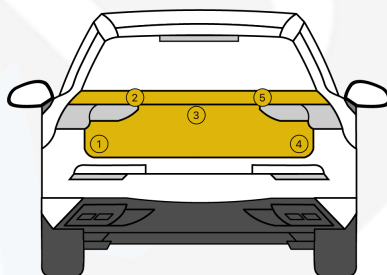
| BACK | | | | | | | | | | | |

| BACK | | | | | | | | | | | |
|---|---|---|---|---|---|---|---|---|---|---|---|
| trunk/boot | Fe+Zn | 175 | 252 | 223 | 231 | 233 | 224 | 252 | 175 | - | - |
