REPORT

Mercedes

Type	SEDAN
Make	Mercedes
Model	S-class
Engine capacity [ccm]	4996
Power [kW]	225
VIN	WDB2201751A051246
Fuel Type	Gas
Year of production	1999

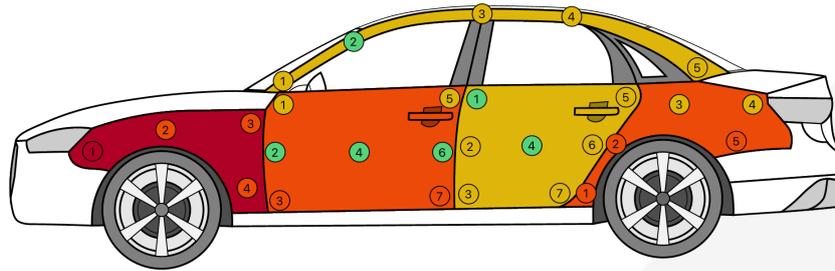
LEFT SIDE											
	Coating	Minimum	Maximum	Medium	1.	2.	3.	4.	5.	6.	7.
left front fender/ bumper	Fe	331	687	457	687	387	422	331	-	-	-
left front door	Fe+Zn	139	336	206	189	155	308	139	166	152	336
left rear door	Fe	155	252	195	155	188	252	155	181	199	236
left pillar	Fe	142	202	177	194	142	174	171	202	-	-
left rear fender/ bumper	Fe	242	464	358	408	393	242	283	464	-	-

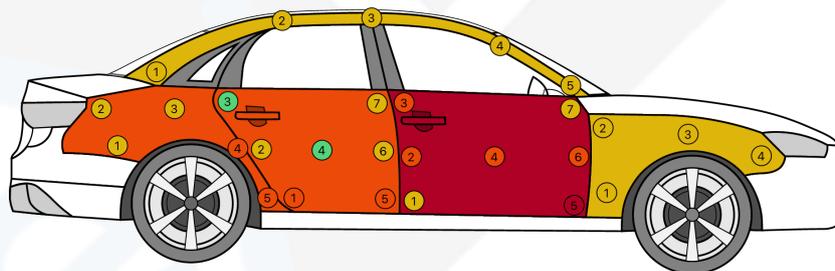
RIGHT SIDE											
	Coating	Minimum	Maximum	Medium	1.	2.	3.	4.	5.	6.	7.
right front fender/ bumper	Fe+Zn	223	240	232	223	234	230	240	-	-	-
right front door	Fe+Zn	242	522	366	283	465	335	306	522	409	242
right rear door	Fe	151	374	229	374	183	164	151	322	208	201
right pillar	Fe	172	261	197	172	177	198	175	261	-	-
right rear fender/ bumper	Fe+Zn	173	342	258	277	176	173	322	342	-	-

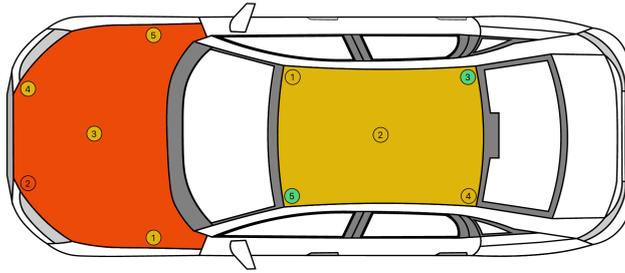
TOP											
	Coating	Minimum	Maximum	Medium	1.	2.	3.	4.	5.	6.	7.
hood/bonnet	Al	172	331	217	189	331	194	199	172	-	-
roof	Fe	156	235	191	203	235	159	201	156	-	-

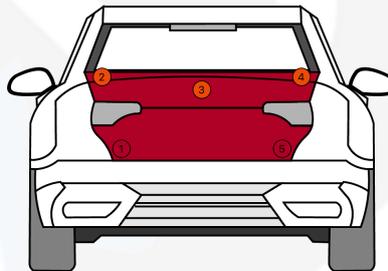
BACK											
	Coating	Minimum	Maximum	Medium	1.	2.	3.	4.	5.	6.	7.
trunk/boot	Fe+Zn	379	585	483	585	379	440	441	569	-	-

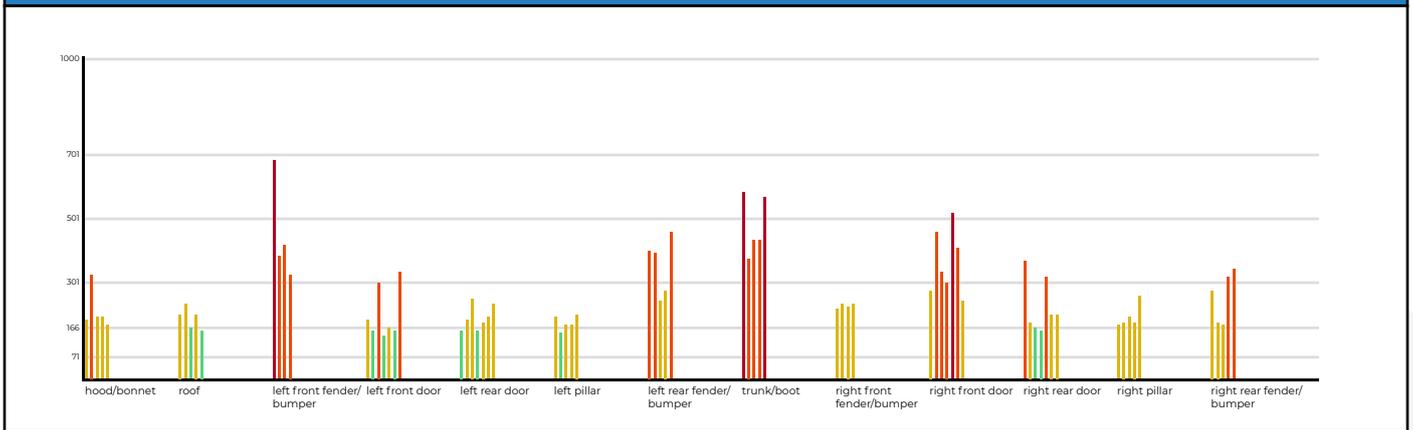
EXTERNAL MEASUREMENTS														
left front fender/ bumper	1. 687	2. 387	3. 422	4. 331	-	-	-	-	-	-	-	-	-	-
right front fender/ bumper	4. 240	3. 230	2. 234	1. 223	-	-	-	-	-	-	-	-	-	-
DIFFERENCE	447	157	188	108										
left front door	1. 189	2. 155	3. 308	4. 139	5. 166	6. 152	7. 336	-	-	-	-	-	-	-
right front door	7. 242	6. 409	5. 522	4. 306	3. 335	2. 465	1. 283	-	-	-	-	-	-	-
DIFFERENCE	53	254	214	167	169	313	53							
left rear door	1. 155	2. 188	3. 252	4. 155	5. 181	6. 199	7. 236	-	-	-	-	-	-	-
right rear door	7. 201	6. 208	5. 322	4. 151	3. 164	2. 183	1. 374	-	-	-	-	-	-	-
DIFFERENCE	46	20	70	4	17	16	138							
left pillar	1. 194	2. 142	3. 174	4. 171	5. 202	-	-	-	-	-	-	-	-	-
right pillar	5. 261	4. 175	3. 198	2. 177	1. 172	-	-	-	-	-	-	-	-	-
DIFFERENCE	67	33	24	6	30									
left rear fender/ bumper	1. 408	2. 393	3. 242	4. 283	5. 464	-	-	-	-	-	-	-	-	-
right rear fender/ bumper	5. 342	4. 322	3. 173	2. 176	1. 277	-	-	-	-	-	-	-	-	-

DIFFERENCE	66	71	69	107	187
