# REPORT

**Renault Midlum**

### PAS: general interpretation, body

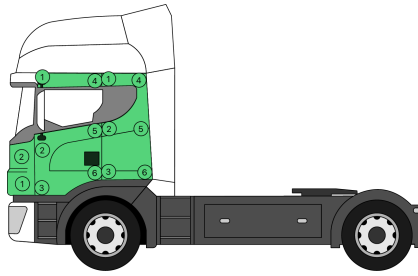
| LEFT SIDE | | | | | | | | | | | |

| LEFT SIDE | | | | | | | | | | | |
|---|---|---|---|---|---|---|---|---|---|---|---|
| left front fender/<br>bumper | Fe | 74 | 82 | 78 | 82 | 74 | - | - | - | - | - |
| left front door | Fe+Zn | 74 | 162 | 104 | 122 | 95 | 93 | 162 | 75 | 74 | - |
| left rear door | Fe+Zn | 93 | 131 | 107 | 107 | 131 | 98 | 118 | 97 | 93 | - |

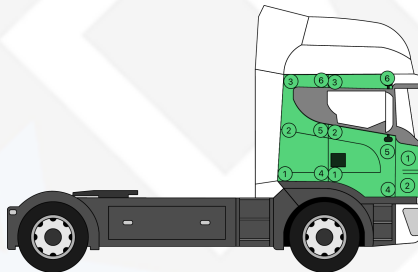
| RIGHT SIDE | | | | | | | | | | | |

| RIGHT SIDE | | | | | | | | | | | |
|---|---|---|---|---|---|---|---|---|---|---|---|
| right front fender/<br>bumper | Fe+Zn | 93 | 104 | 98 | 104 | 93 | - | - | - | - | - |
| right front door | Fe+Zn | 79 | 149 | 98 | 85 | 94 | 149 | 79 | 85 | 93 | - |
| right rear door | Fe+Zn | 97 | 136 | 110 | 97 | 109 | 100 | 107 | 136 | 114 | - |
