# REPORT

**Opel insignia**

## PAS: general interpretation, body

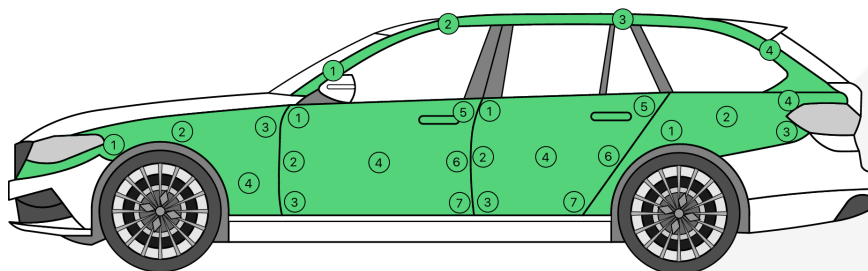
| LEFT SIDE | | | | | | | | | | | |

| LEFT SIDE | | | | | | | | | | | |
|---|---|---|---|---|---|---|---|---|---|---|---|
| left front fender/ bumper | Fe+Zn | 85 | 134 | 109 | 85 | 106 | 111 | 134 | - | - | - |
| left front door | Fe+Zn | 109 | 151 | 130 | 140 | 129 | 113 | 151 | 137 | 134 | 109 |
| left rear door | Fe | 87 | 127 | 110 | 120 | 125 | 103 | 127 | 105 | 100 | 87 |
| left pillar | Fe | 87 | 108 | 96 | 93 | 96 | 108 | 87 | - | - | - |
| left rear fender/ bumper | Fe+Zn | 111 | 155 | 123 | 114 | 111 | 111 | 155 | - | - | - |

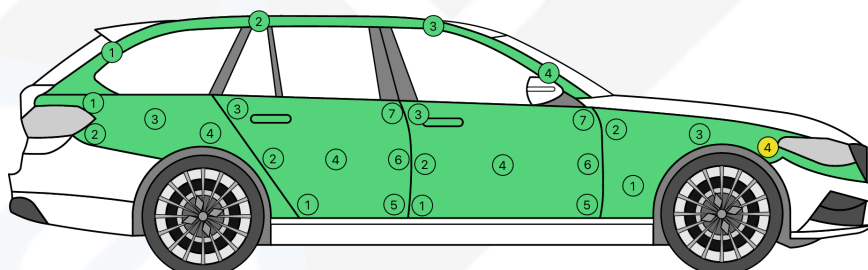
| RIGHT SIDE | | | | | | | | | | | |

| RIGHT SIDE | | | | | | | | | | | |
|---|---|---|---|---|---|---|---|---|---|---|---|
| right front fender/ bumper | Fe+Zn | 63 | 116 | 96 | 89 | 115 | 116 | 63 | - | - | - |
| right front door | Fe+Zn | 123 | 157 | 139 | 123 | 139 | 138 | 157 | 124 | 149 | 146 |
| right rear door | Fe | 88 | 133 | 109 | 88 | 93 | 123 | 112 | 109 | 102 | 133 |
| right pillar | Fe+Zn | 75 | 129 | 90 | 77 | 75 | 81 | 129 | - | - | - |
| right rear fender/ bumper | Fe | 104 | 124 | 118 | 104 | 124 | 120 | 122 | - | - | - |

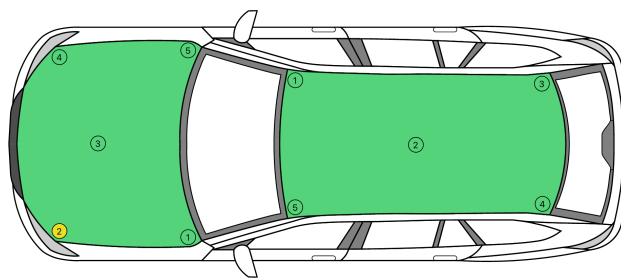
| TOP | | | | | | | | | | | |

| TOP | | | | | | | | | | | |
|---|---|---|---|---|---|---|---|---|---|---|---|
| hood/bonnet | Al | 57 | 114 | 96 | 114 | 57 | 112 | 92 | 104 | - | - |
| roof | Fe | 108 | 140 | 123 | 108 | 119 | 126 | 120 | 140 | - | - |

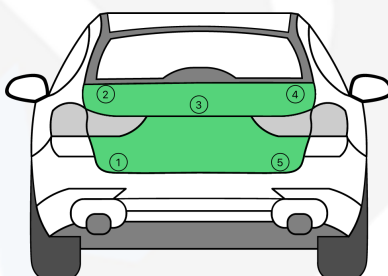
| BACK | | | | | | | | | | | |

| BACK | | | | | | | | | | | |
|---|---|---|---|---|---|---|---|---|---|---|---|
| trunk/boot | Fe+Zn | 126 | 132 | 129 | 130 | 132 | 126 | 130 | 129 | - | - |

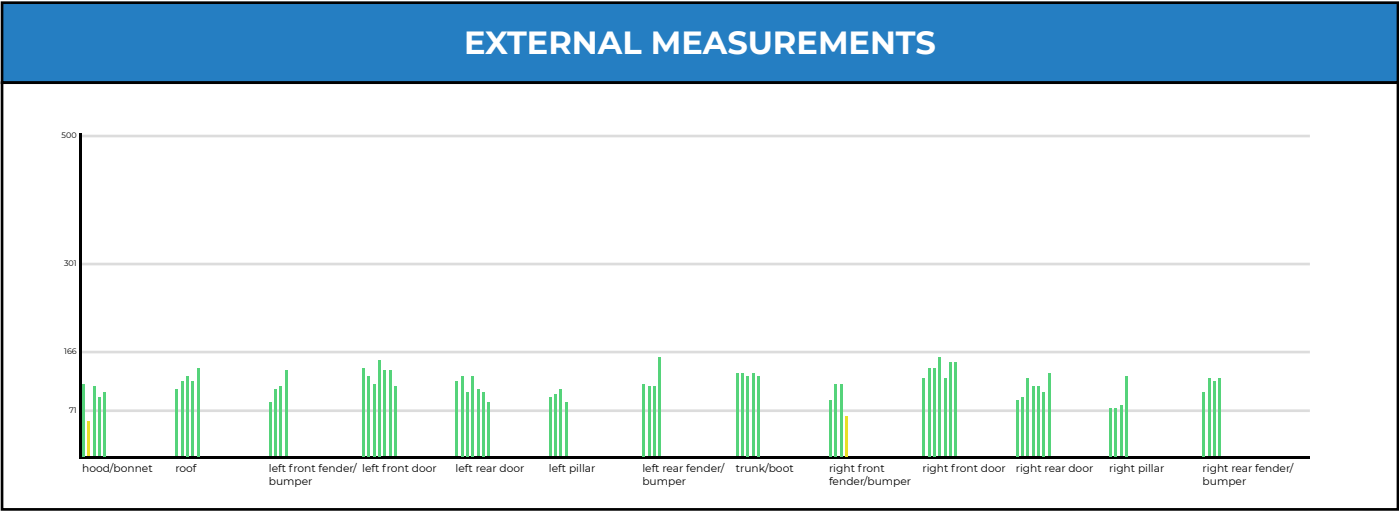
- Disabled
- Paint layer is too thin
- Paint layer is original
- Second layer of paint
- A thin layer of putty
- A thick layer of putty
