# REPORT

**Skoda kidiaq**

| Model | <b>Kodiaq</b> |
| VIN | <b>TMBLK7NS1K8073435</b> |

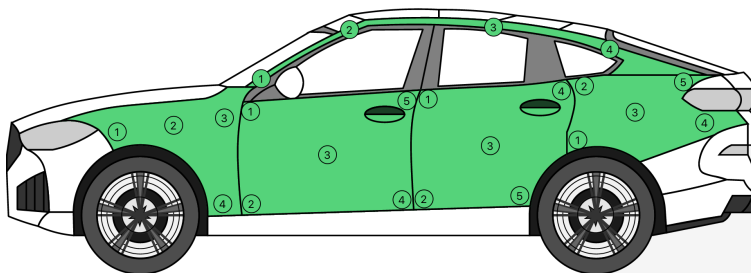
| LEFT SIDE | | | | | | | | | | | |

| LEFT SIDE | | | | | | | | | | | |
|---|---|---|---|---|---|---|---|---|---|---|---|
| left front fender/bumper | Fe+Zn | 88 | 117 | 103 | 101 | 117 | 105 | 88 | - | - | - |
| left front door | Fe+Zn | 108 | 122 | 117 | 121 | 108 | 116 | 119 | 122 | - | - |
| left rear door | Fe | 85 | 123 | 112 | 117 | 123 | 116 | 120 | 85 | - | - |
| left pillar | Fe+Zn | 91 | 133 | 110 | 133 | 91 | 102 | 115 | - | - | - |
| left rear fender/bumper | Fe+Zn | 117 | 138 | 129 | 117 | 138 | 120 | 136 | 133 | - | - |

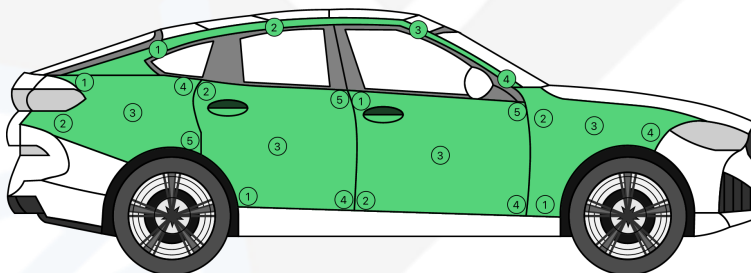
| RIGHT SIDE | | | | | | | | | | | |

| RIGHT SIDE | | | | | | | | | | | |
|---|---|---|---|---|---|---|---|---|---|---|---|
| right front fender/bumper | Fe | 82 | 110 | 100 | 82 | 103 | 105 | 110 | - | - | - |
| right front door | Fe+Zn | 103 | 126 | 115 | 120 | 121 | 104 | 103 | 126 | - | - |
| right rear door | Fe+Zn | 82 | 125 | 107 | 82 | 114 | 108 | 106 | 125 | - | - |
| right pillar | Fe | 90 | 116 | 104 | 114 | 95 | 90 | 116 | - | - | - |
| right rear fender/bumper | Fe+Zn | 95 | 128 | 112 | 95 | 114 | 101 | 128 | 122 | - | - |

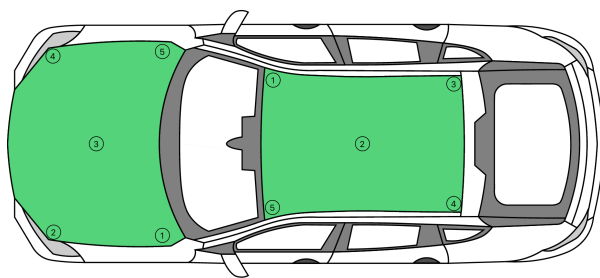
| TOP | | | | | | | | | | | |

| TOP | | | | | | | | | | | |
|---|---|---|---|---|---|---|---|---|---|---|---|
| hood/bonnet | Fe+Zn | 88 | 124 | 104 | 99 | 88 | 124 | 111 | 98 | - | - |
| roof | Fe+Zn | 121 | 141 | 131 | 128 | 138 | 126 | 121 | 141 | - | - |

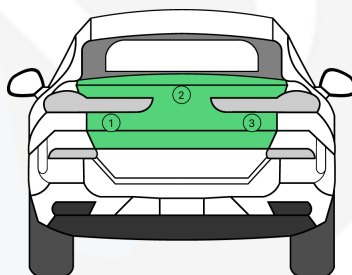
| BACK | | | | | | | | | | | |

| BACK | | | | | | | | | | | |
|---|---|---|---|---|---|---|---|---|---|---|---|
| trunk/boot | Fe+Zn | 116 | 127 | 123 | 127 | 116 | 127 | - | - | - | - |
